SARDIS, 2009

Nicholas Dunlop CAHILL¹

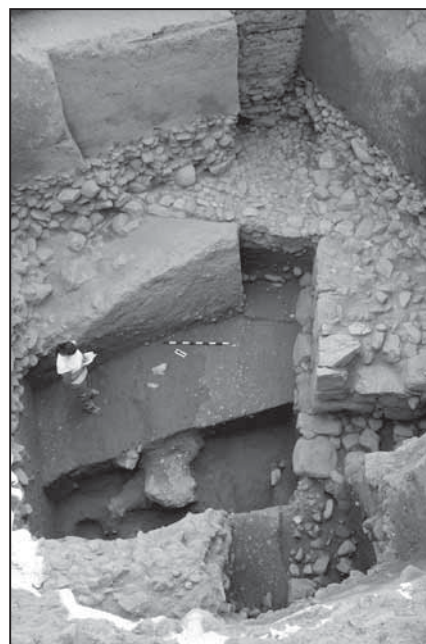
Fig. 2: Sector MMS: view showing early structure underneath the monumental Lydian fortification.

Excavation was undertaken in four sectors of the city: at the western fortification, at two locations in central Sardis, and on the Acropolis (Fig. 1). At sector MMS, work focused on an earlier Lydian structure, probably a defense, underneath the monumental Lydian fortification. A trench begun in 2008 had revealed a corner of the structure, which had also been glimpsed in 1977. This corner is not a gate or opening in the wall, since the foundations continue on to the south; it may rather be the corner of a recess like those found in the later fortification. In 2009, the trench was expanded to the north to reveal more of this wall. The wall is interrupted by a stone feature, with a very rough “face” at right angles to the line of the fortification (Figs. 2-3). This line of stones is probably the back edge of a retaining or terrace wall; the deposit south of this face was an artificial fill consisting of lenses of different types of earth, consistent with this interpretation. The north side of this wall could not be exposed, as it is under the modern road; the retaining wall, if this is what it is, is at least three meters thick (Fig. 4). This earlier phase of the fortification, therefore, seems to have had some of the elements of design of the later wall, such as a recess in the original construction, and a later reinforcement, with an earthwork supported by a massive retaining wall. The date of this earlier phase is probably in the second half of the seventh century B.C.

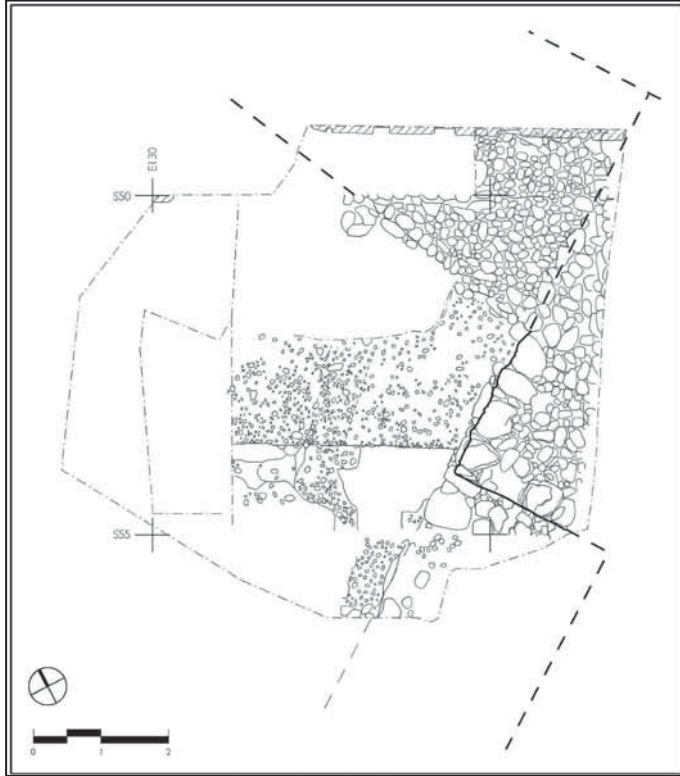
Fig. 3: Sector MMS: plan of excavation trench with part of early fortification.

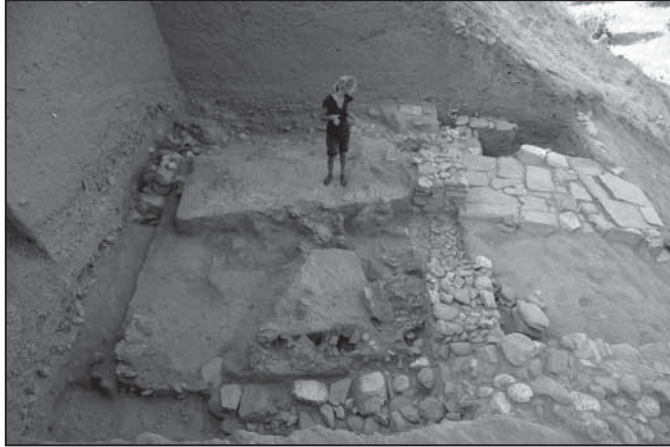
Fig. 5: Sector ThSt: View of Lydian house during excavation.

Underneath the Hellenistic fill of the theater was a well-preserved Lydian building, probably a house. One space of this house, presumably an open space with a stone paved floor and limestone column, had been excavated in previous seasons. In 2009 a second room, measuring about 3.5 x 3.9 m, was cleared almost to floor level (Fig. 6). Entered through a door from the previously excavated space to its east, this was probably roofed; it may also have had a door to the west. Its floor area was largely taken up by two mudbrick benches or platforms, whose function was not completely clear. The corridors between these benches were littered with artifacts, including at least nine cooking pots, fragments of at least one Myrina amphora, at least one stemmed dish, at least one omphalos phiale, a lid, eleven loomweights and ten spindle whorls, and other pottery which remains to be cleared, mended and studied. Among the complete finds were a lamp, a lydion, a juglet, and a Corinthian warrior *aryballos* (Fig. 7). Fragments of other imported vases of this same date were discovered as well, including two sherds of an Attic black-figured cup, perhaps a proto-Cassel cup, and a fragment of a Chiot chalice. Datable to the second quarter of the sixth century B.C., these are the first solid evidence that the destruction of this house, like the houses previously excavated near the fortification, is to be attributed to Cyrus the Great in about 547 B.C. One unusual local find is a conventional Lydian streaky-glazed *skyphos*; its accidental burning in the destruction of the house revealed part of a design that had apparently been painted over, including part of a lion and filling ornaments.

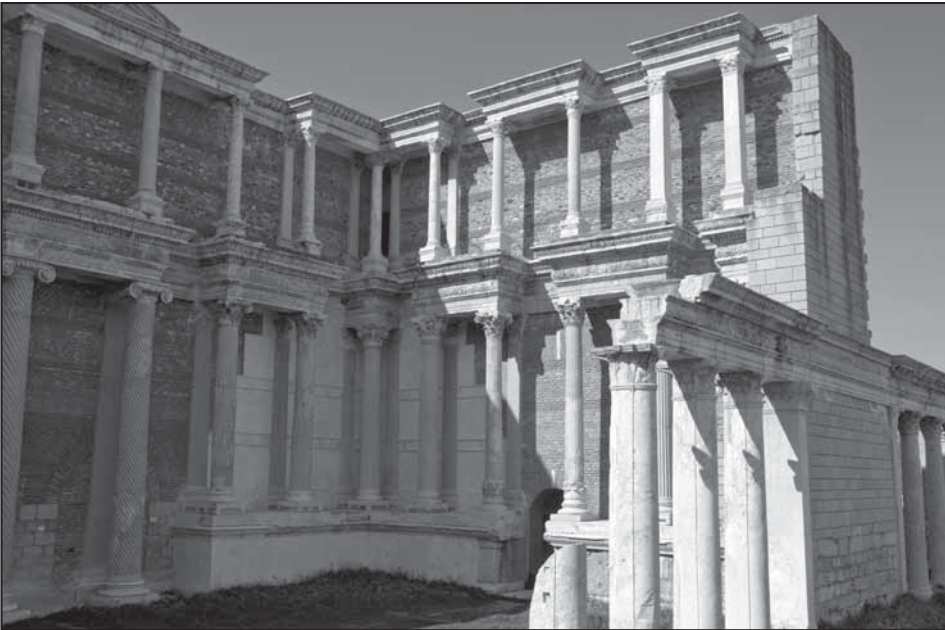
Fig. 13: Reconstruction of the revetment of the Marble Court.

The project begun in 2007 to restore a corner of the marble revetment in the Marble Court, was brought to completion. Panels of Afyon marble, were fixed to a steel frame, set in modern restoration to avoid damage to the original structure. The pattern was based as far as possible on existing remains, but where the design is uncertain — as it is for most of the superstructure — the reconstruction was kept deliberately simple (Fig. 13).
